Swanage North Beach Cliffs

Document: 474874-1 Version: 1.1

Site Inspection Report

Purbeck District Council

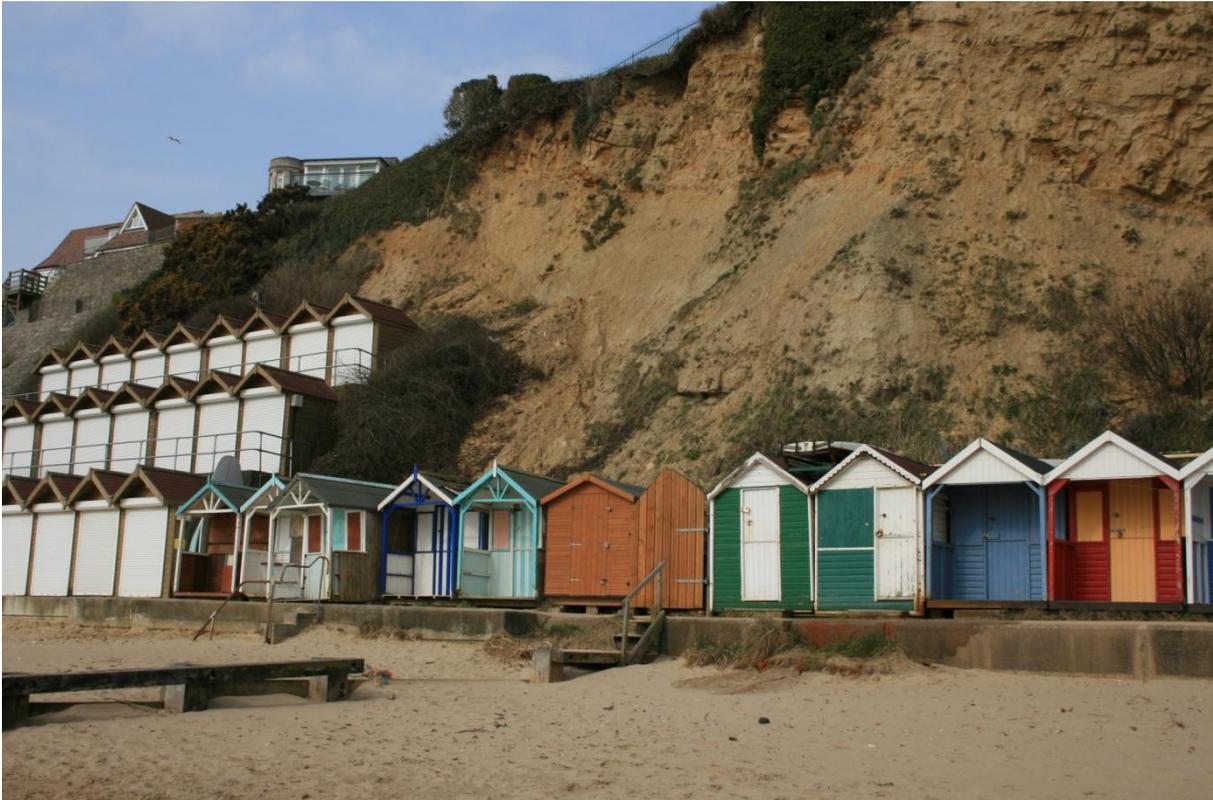
The source of the failure extends 15m across and behind the adjacent three-tier beach hut development of block wall construction to the south (Plate 1); the retaining wall behind this development shielded the huts from the cliff fall and acted to divert the debris towards the adjacent property to the north impacting a single row of timber beach huts (Plates 1 & 2). Further cliffs falls and debris run-out are likely given the exposure of the bare sub-vertical cliff face and accumulated talus on the slope, posing a risk to the beach huts, and public and promenade beneath.

Plate 1 – Site 2 Cliff fall and debris run-out above 3-tier and single rows of beach huts

- Cliff fall and debris slide run-out at Sites 2-4 poses a substantial risk to a single row of 30 timber beach huts and the promenade. A makeshift barrier erected above the beach huts is close to failure, adding to the risk. Cliff protection measures and a rock catch fence should be installed to protect the beach huts and occupants, and the public using the promenade.

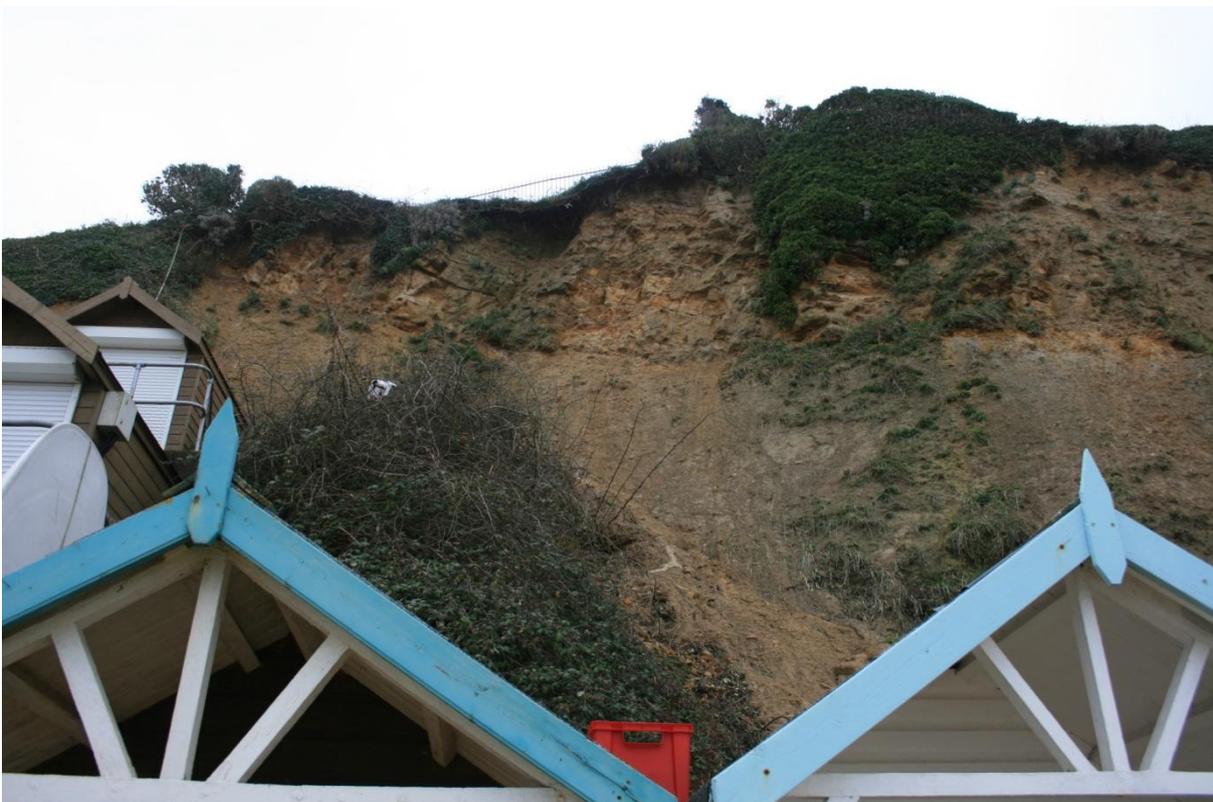
Plate 2 – Site 2 Cliff fall and debris run-out above single row of beach huts

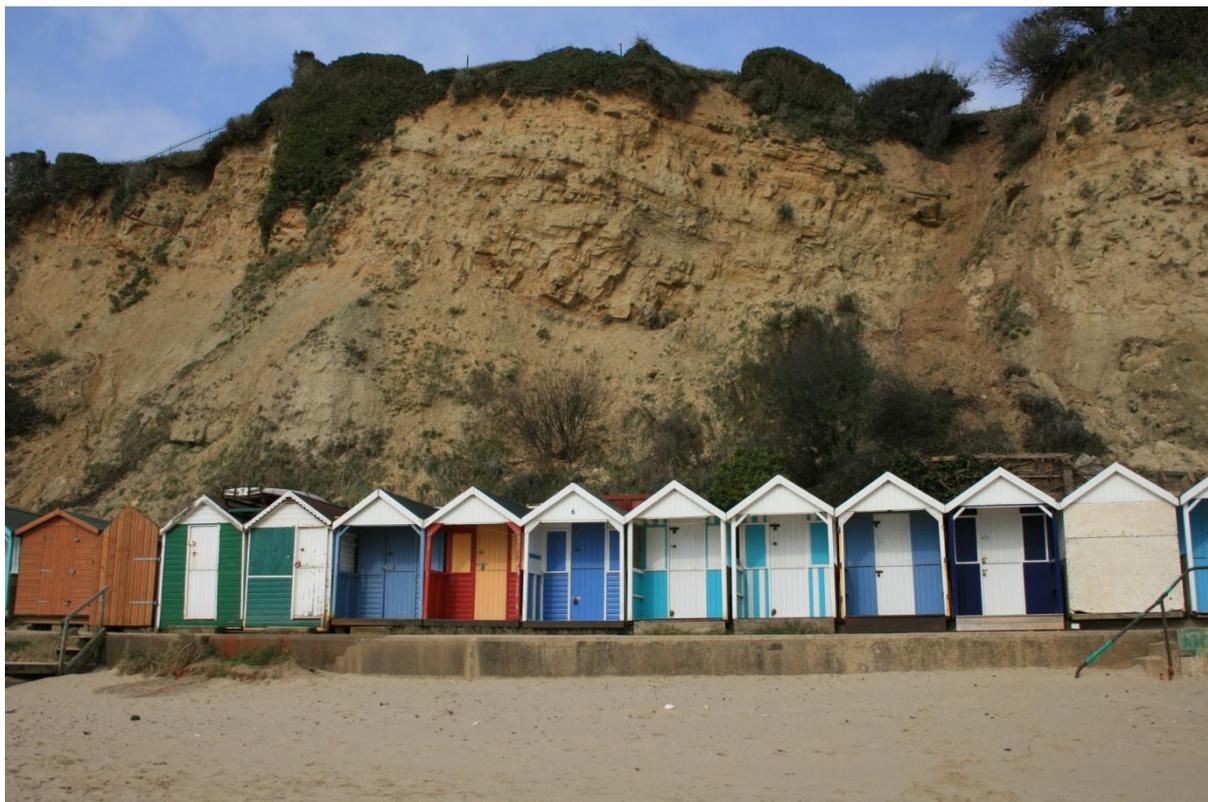
A rock fall and debris cone was observed above a single row of timber beach huts (Figure 1; Plate 3). The rock fall source measures 5m by 8m with an estimated volume up to 10m³. The debris cone (talus) measures approximately 10m by 8m with an estimated volume of 40 m³.

The cliff fall debris has accumulated above a makeshift retaining wall formed of steel scaffold poles and timber planks above a low block retaining wall of 0.5m height. The makeshift structure is unsuited to withstand significant earth pressures and appears close to failure in places.

A single row of 30 beach huts are located in front of the low block retaining wall. They are at risk of direct impact from falling rock from above and from failure of the makeshift wall and talus; the latter is most likely in the winter when groundwater levels are high and could result in significant run-out of debris onto the promenade and beach, destroying the beach huts in its path and posing a risk to the public.

Plate 3 – Site 3 cliff fall chute and debris accumulation

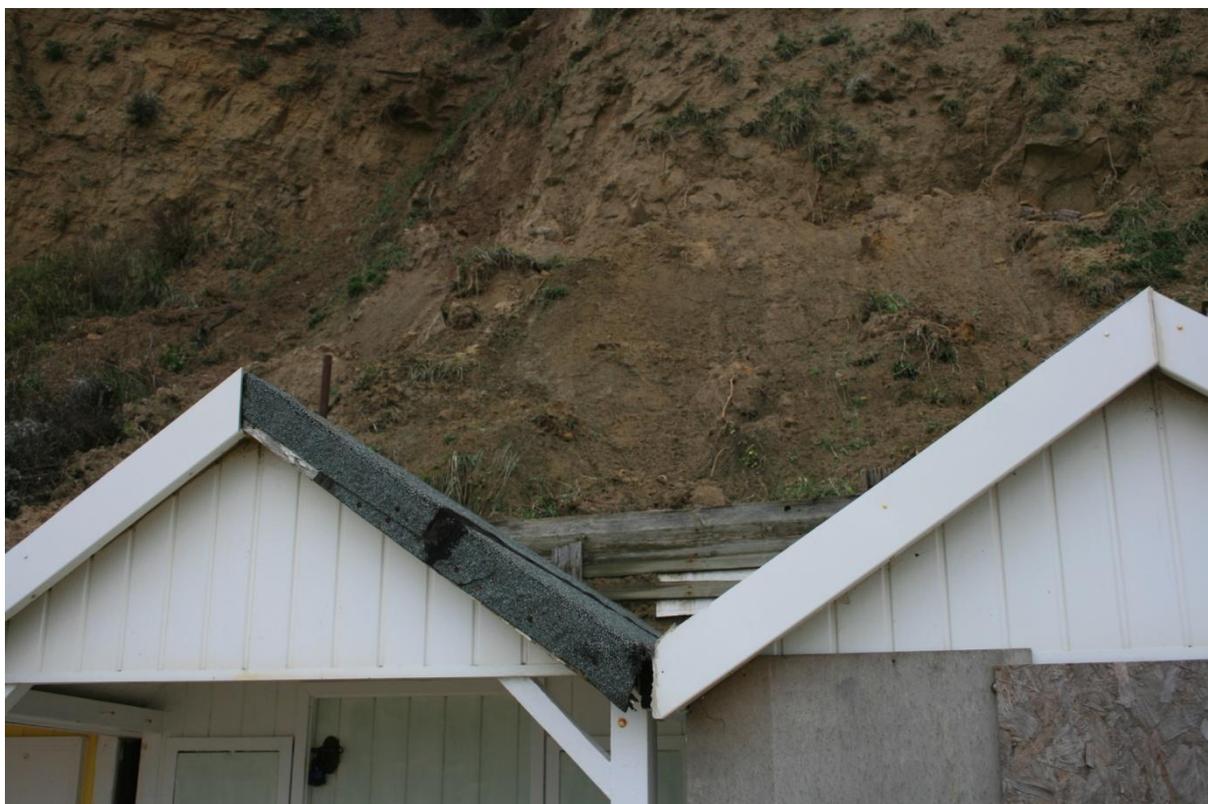
Plate 4 – Site 4 cliff fall debris and makeshift barrier

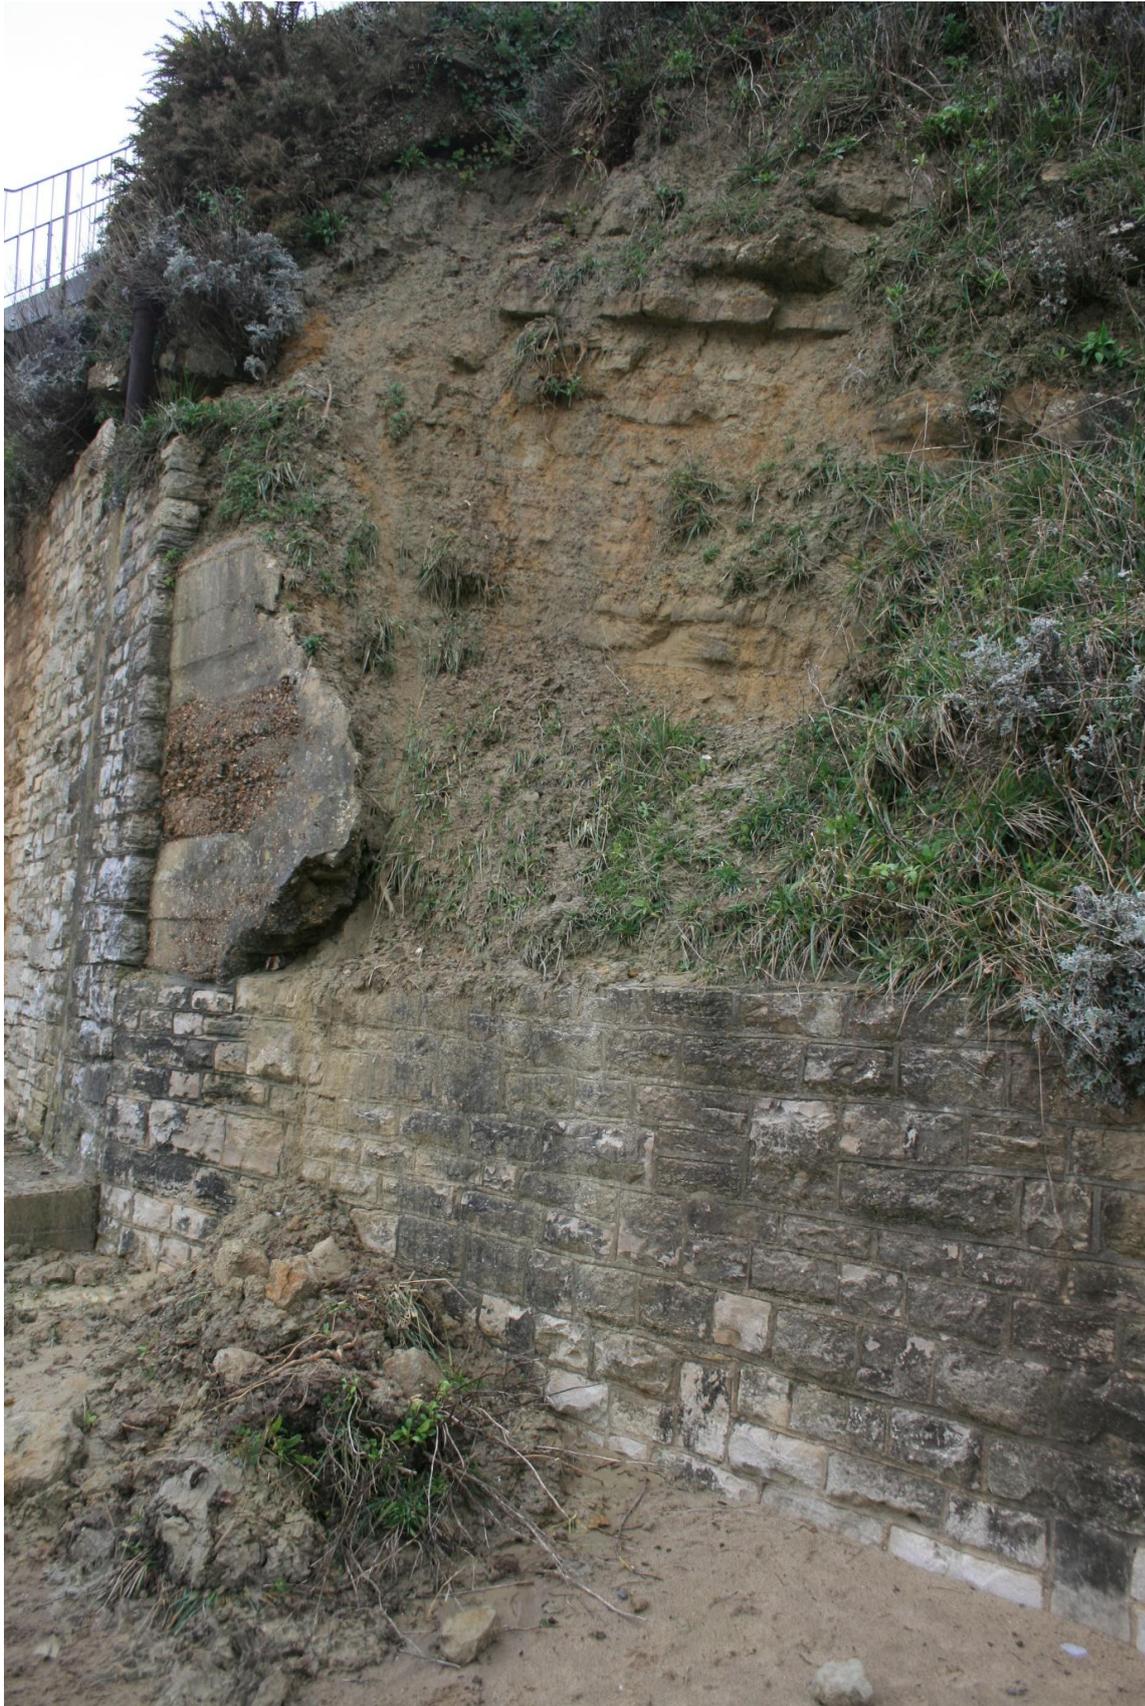
A minor debris fall occurred on the steep cliff flanking the southern boundary to the Grand Hotel's frontage (Figure 1; Plate 5). The slip was reported at 16.00 on Friday 21 Dec 2012 by the Coastguard (BBC online news, 22 Dec 2012). The debris accumulation on the promenade was less than 1m³ (see Plate 5) and had been cleared by the time of the inspection. The debris fall occurred on a section of cliff that once had a protective block wall facing that has failed in the past and fallen into disrepair.

Plate 5 – Site 6 Minor cliff fall and debris

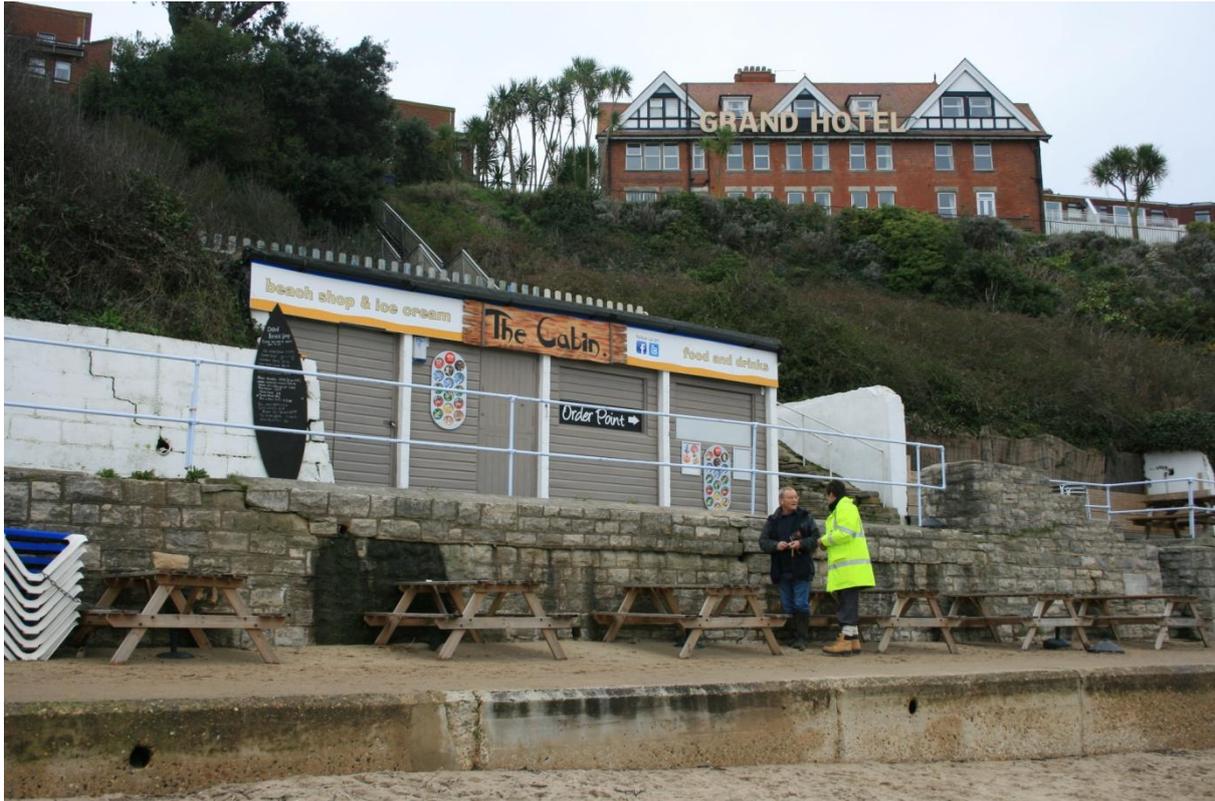
Damage to the block walls, paving and facilities on the lower cliff at the Grand Hotel appear to have been caused by landslip (Figure 1; Plate 6). Outward displacement of the upper course of block work and continuity of open cracks through walls and paving, is indicative of translational displacement of the lower cliff *en masse* and measures 20m across; the depth of landslip appears relatively shallow (1-2m) and rates of movement are likely to be extremely slow.

There is potential for ongoing and future movement of the lower cliff but given that rates of movement are extremely slow the risk to people is negligible. Ongoing landslip will have an adverse impact on structures, walls and paving and could render them dangerous without correction and repair. A development proposal of the lower cliffs at the Grand Hotel is presently be considered by the planning authority; a full stability report, ground investigation and design of cliff stabilisation measures will be required to support the proposals.

Plate 6 – Site 7 landslip damage to block walls on the lower cliff at the Grand Hotel

- The shallow landslide at Site 7 (Grand Hotel) affects mostly private land but outward displacement of the block wall above the promenade poses a hazard to residents and the public, and the site should be stabilised and repaired.

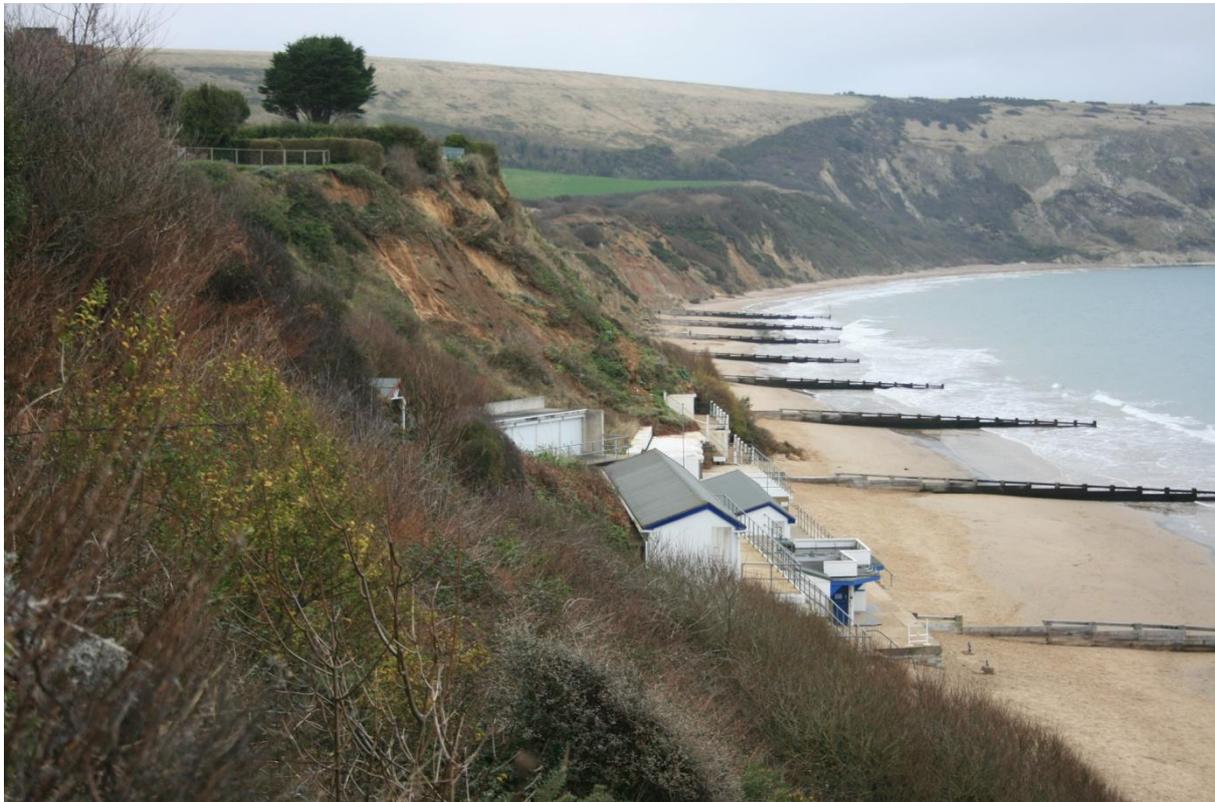
A large cliff failure and landslip occurred at site 8 (Figure 2) which was captured on film and reported in the media 2012 (BBC online news, 22 Dec 2012). The slip measures approximately 15m by 17m with an estimated volume of 127m³. The landslip debris ran-out and came to rest upon a 3-tier and adjacent 2-tier block of beach huts and promenade (Plates 7-11). Although a significant mass of debris came to rest on the beach huts (of block-wall and concrete slab roof construction) they appear structurally intact. Some clearance of debris from the upper terrace and beach huts roof had been carried out at the time of the inspection.

There is potential for further movement and addition of cliff fall and landslip debris above the beach huts. Debris that has come to rest upon the beach huts roof will be applying load that could cause failure of the roof elements or indeed collapse of the multi-tier blocks of beach huts. The 3-tier block being of older construction appears particularly vulnerable to damage from loading of cliff fall and landslide debris.

Plate 7 – Site 8 (mid-distance) cliff failure and debris run-out onto multi-tier beach huts

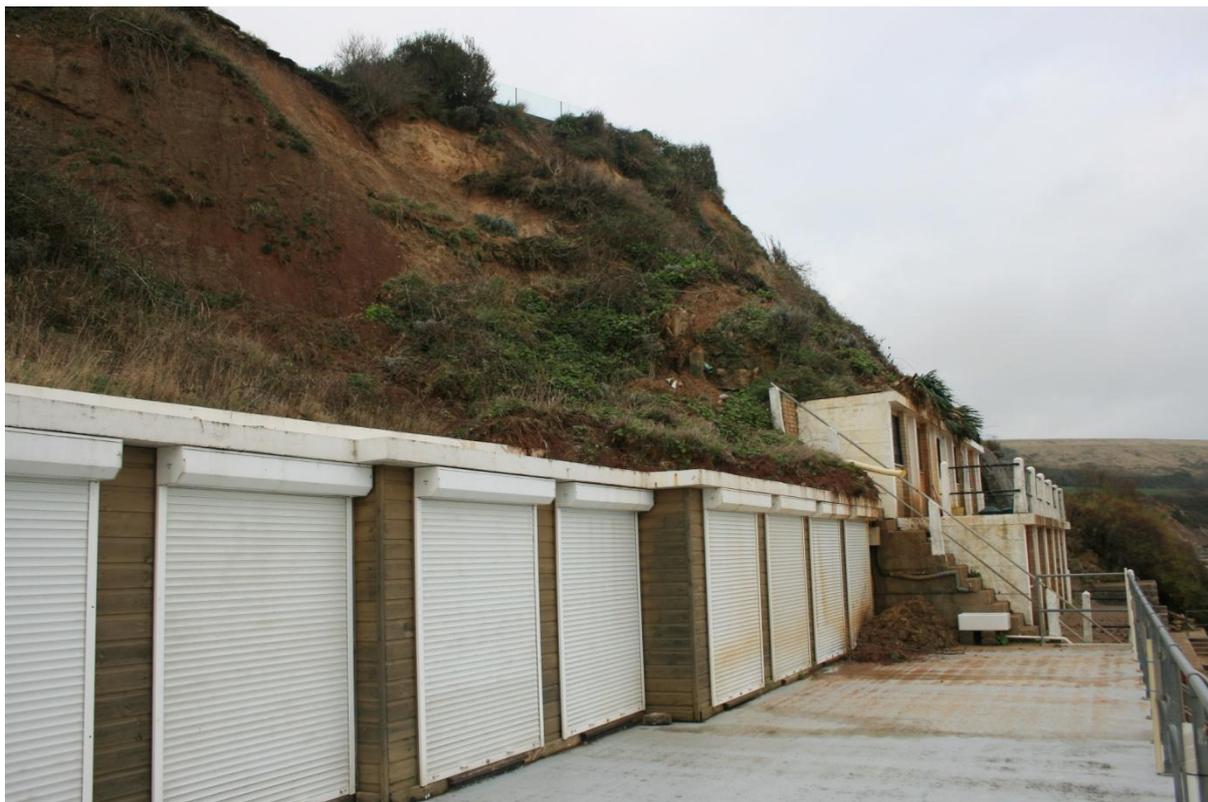
Plate 8 – Site 8 landslide and debris run-out onto multi-tier beach huts – looking north

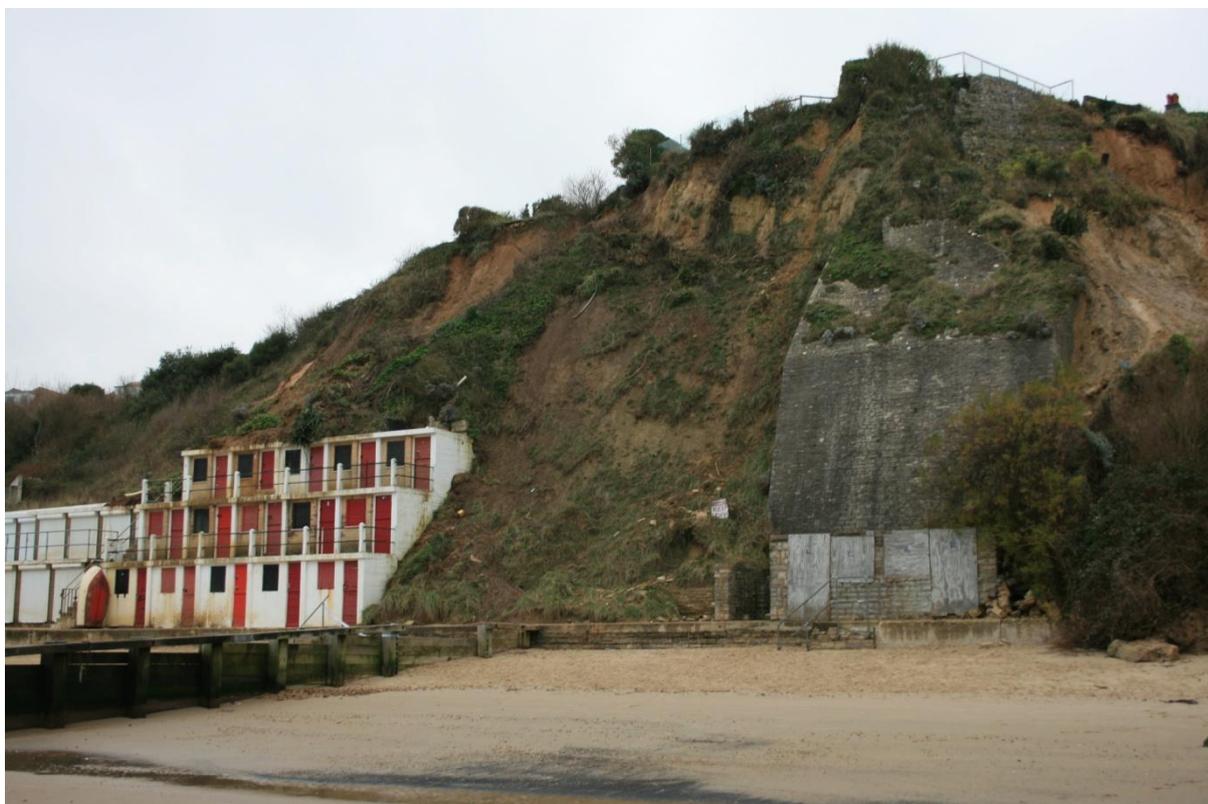
Plate 9 – Site 8 landslide and debris run-out onto multi-tier beach huts – looking west

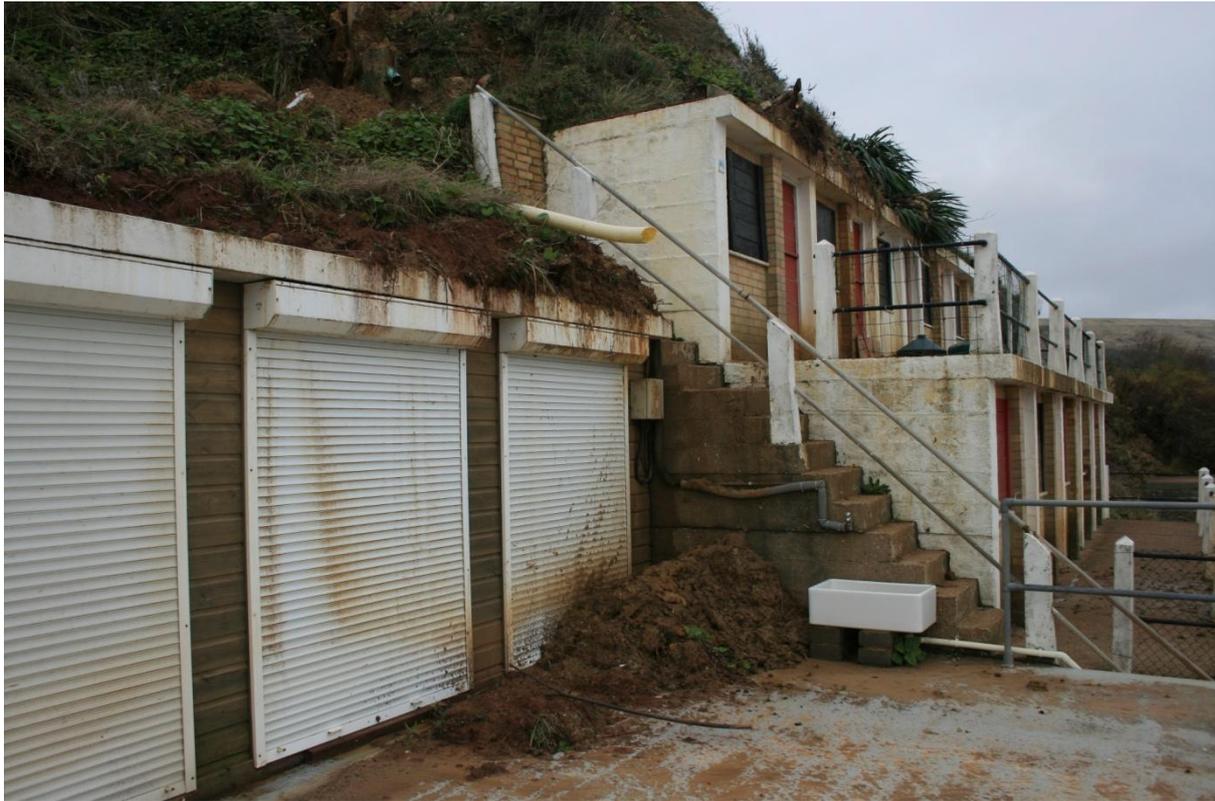
Plate 10 – Site 8 landslide debris run-out impact on multi-tier beach huts

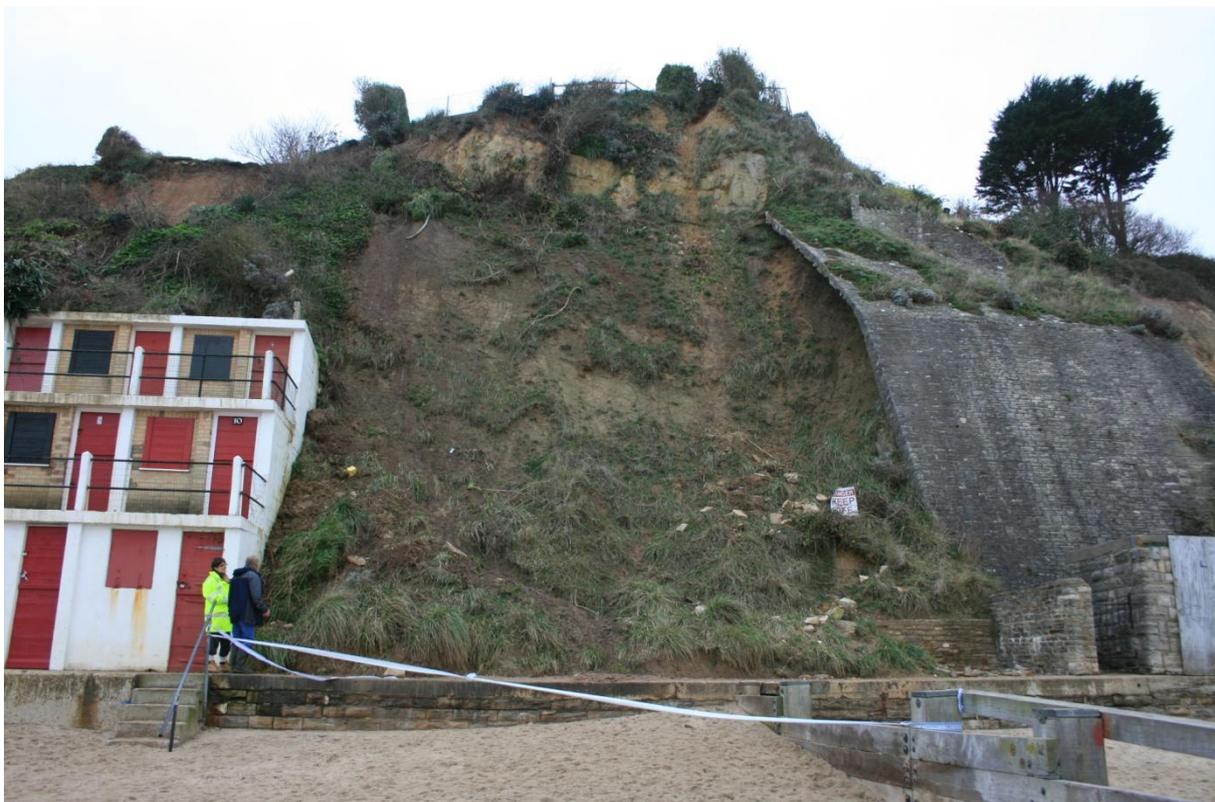
Plate 11 – Site 8 landslide debris run-out onto promenade

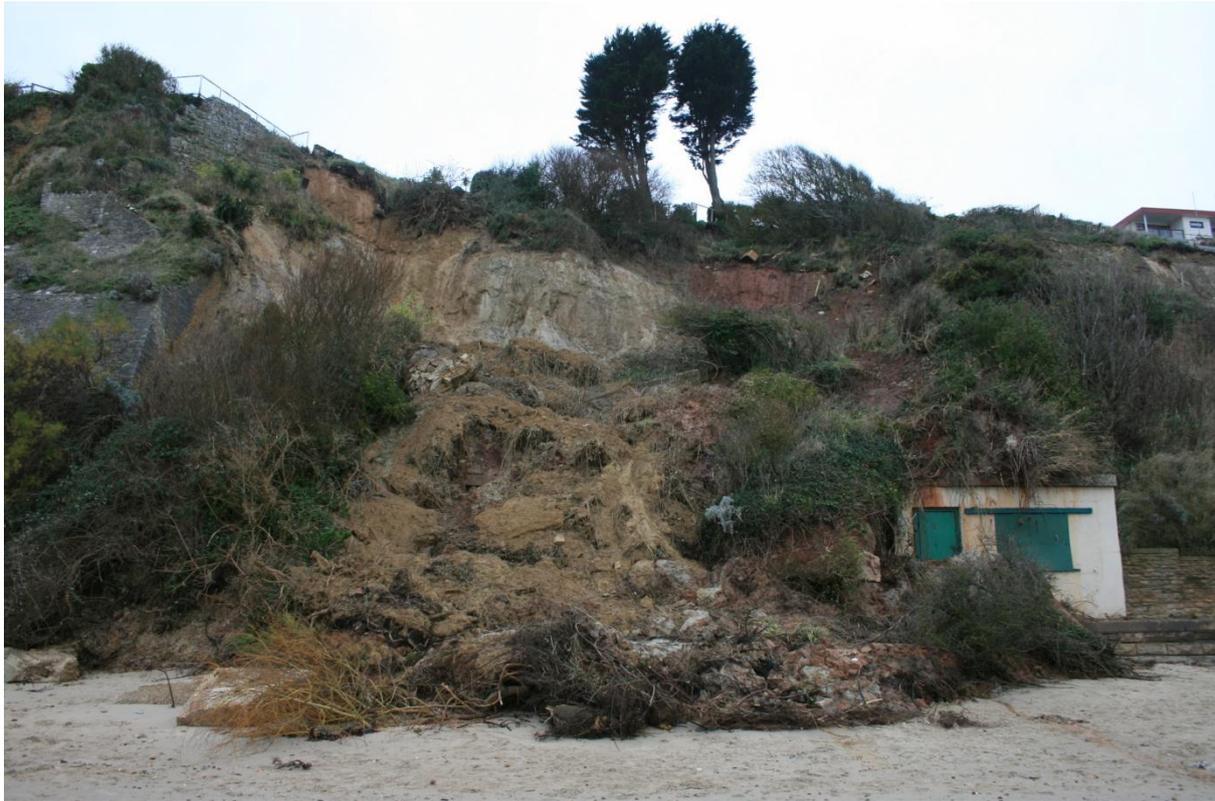
The cliffs fronting properties 30-32 Burlington Road (Figure 2; Plates 12-14) had been affected by small-scale landslip for several years (Halcrow 2005). Over the period late Dec 2012 and March 2013, large-scale failure of the cliffs occurred, forming two elongate mudslides with a distinctive source, track and debris lobe. The mudslides are up to 36m long from crest to toe, 10m wide, and between 0.5-1.5m deep, with an estimated total volume of displaced material up to 400 m³.

Plate 12 – Site 9 landslide debris run-out over promenade and upper beach – looking west

Sites 9-11: excavation of the landslide debris will leave an unsupported cut slope in debris on the lower cliffs which will lead to further cliff instability and debris run-out. It is recommended that a retaining wall, up to 1.5m high, is designed and constructed at the rear of the existing promenade to support the excavation, over a 110m length. The wall should allow free drainage of the cliffs and debris upslope and be designed to provide sufficient passive restraint to stabilise the cut slope in landslip debris on the lower cliffs.

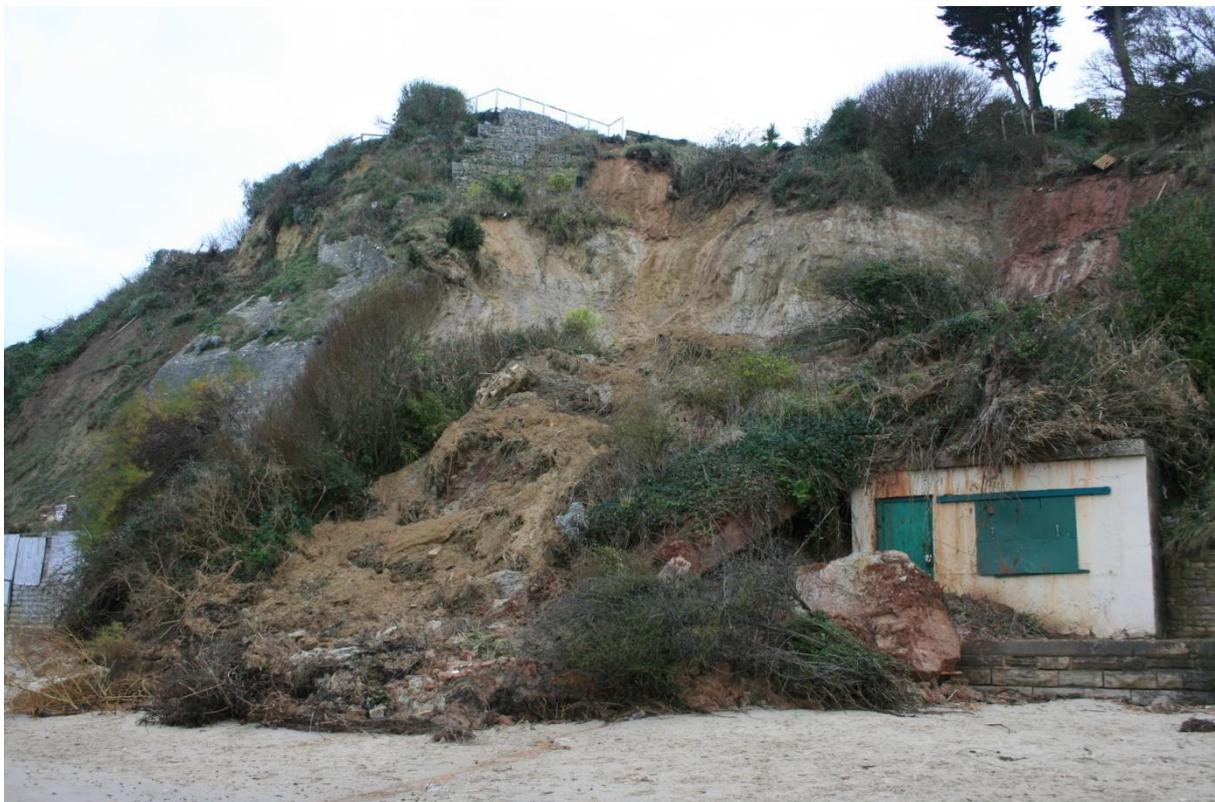
Plate 13 – Site 9 landslide debris run-out over promenade and upper beach – looking southwest

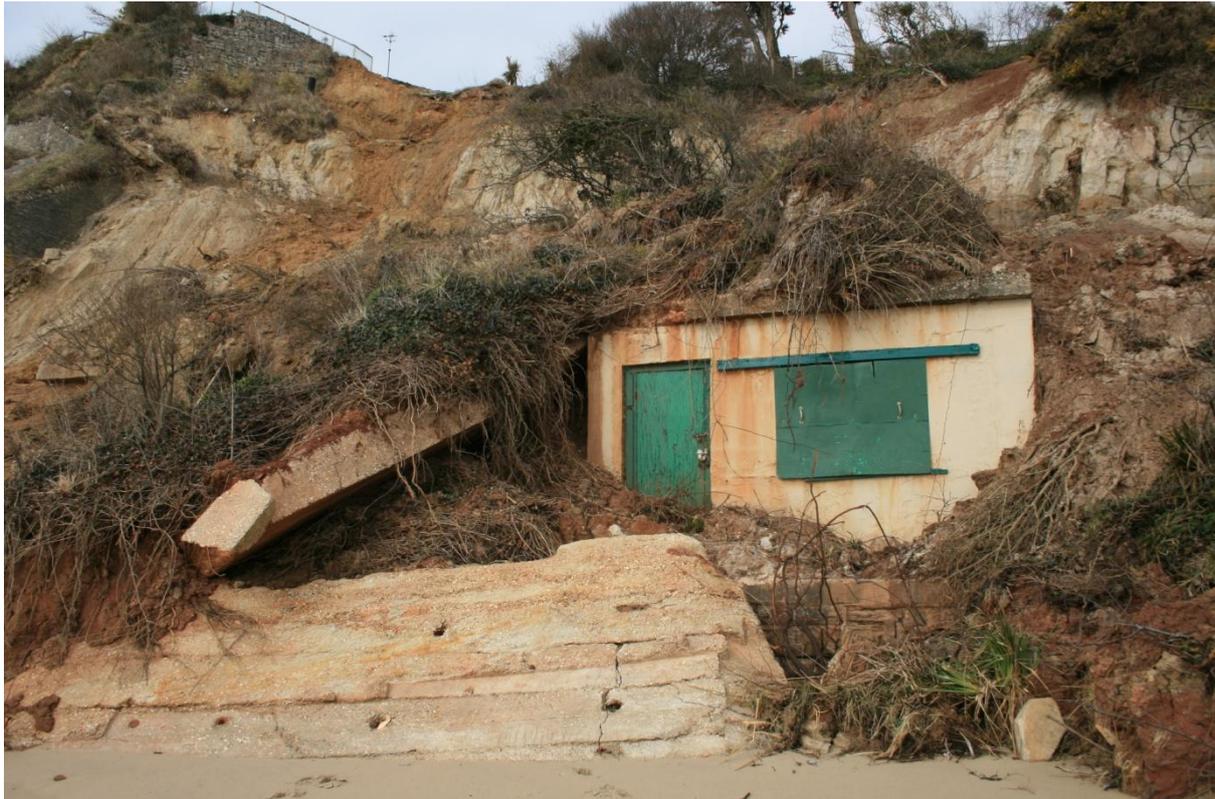
Plate 14 – Site 9 close-up of landslip debris and structural elements

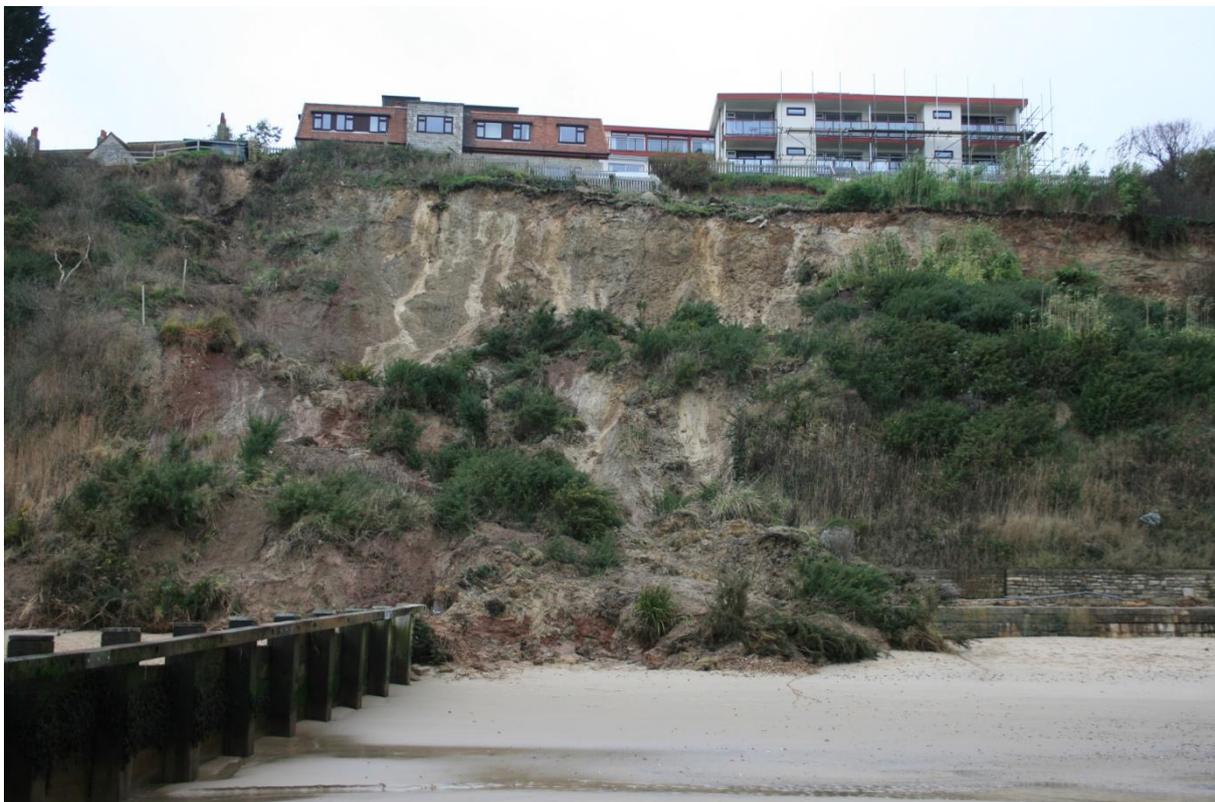
The cliffs fronting the Pines Hotel were affected by widespread instability between Dec 2012 and Mar 2013 (Figure 2; Plates 15-17). The cliffs may be sub-divided into 3 main sections, the cliff-top, mid-cliff and lower cliff. Failure of the mid-cliff section has resulted in run-out and deposition of debris on the promenade and upper beach; this in turn has resulted in collapse and recession of the cliff-top by up to 10m measuring 60m across (Plates 16-17). Two main areas of deposition are shown in Figure 3 measuring 15m by 25m and 40m by 12m, and between 0.5m to 1.5m deep; estimated total volume of displaced debris is 855 m³. The primary cause of failure is attributed to the extreme rainfall and groundwater levels experienced over the autumn and winter period.

Plate 15 – Site 10 landslip and run-out of cliffs beneath the Pines Hotel

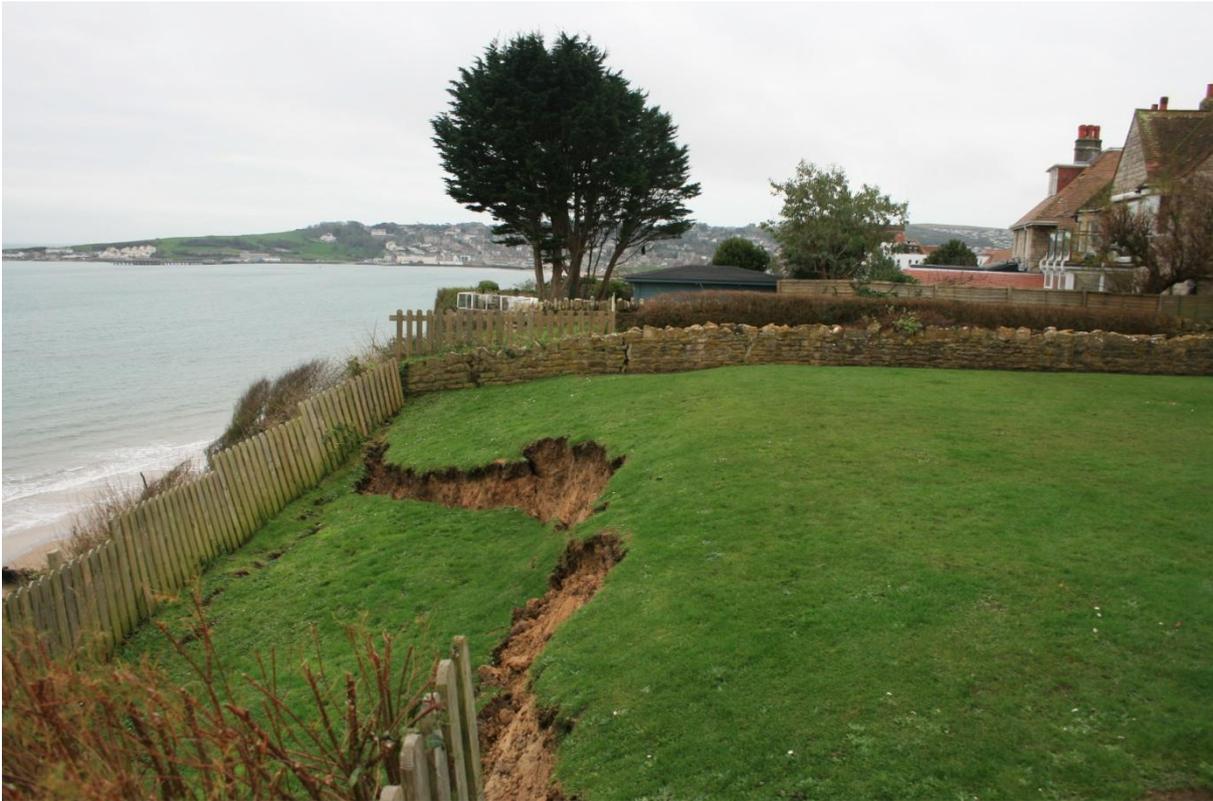
Plate 16 – Site 10 failure of cliff top at the Pines Hotel – looking southwest

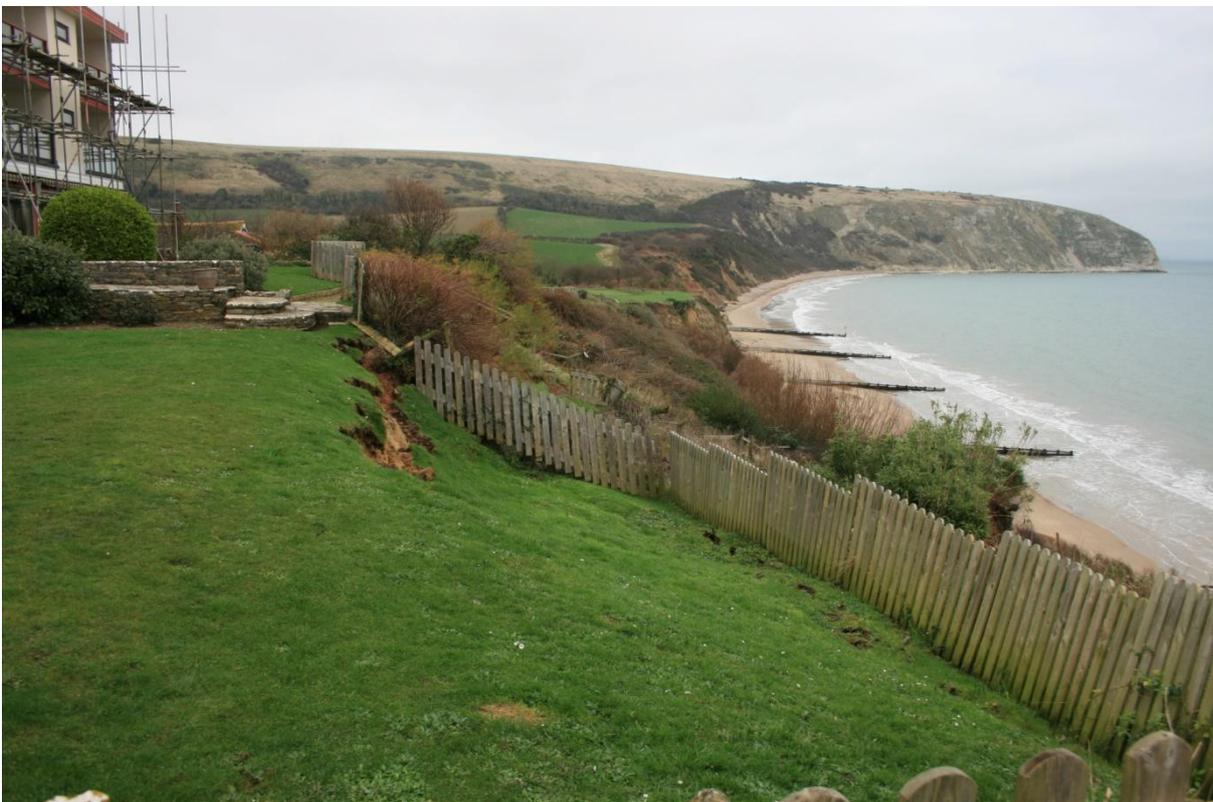
Plate 17 – Site 10 failure of cliff top at the Pines Hotel – looking north
