Swanage North Beach Cliffs

Document: 474874-1 Version: 1.1

Site Inspection Report

Purbeck District Council

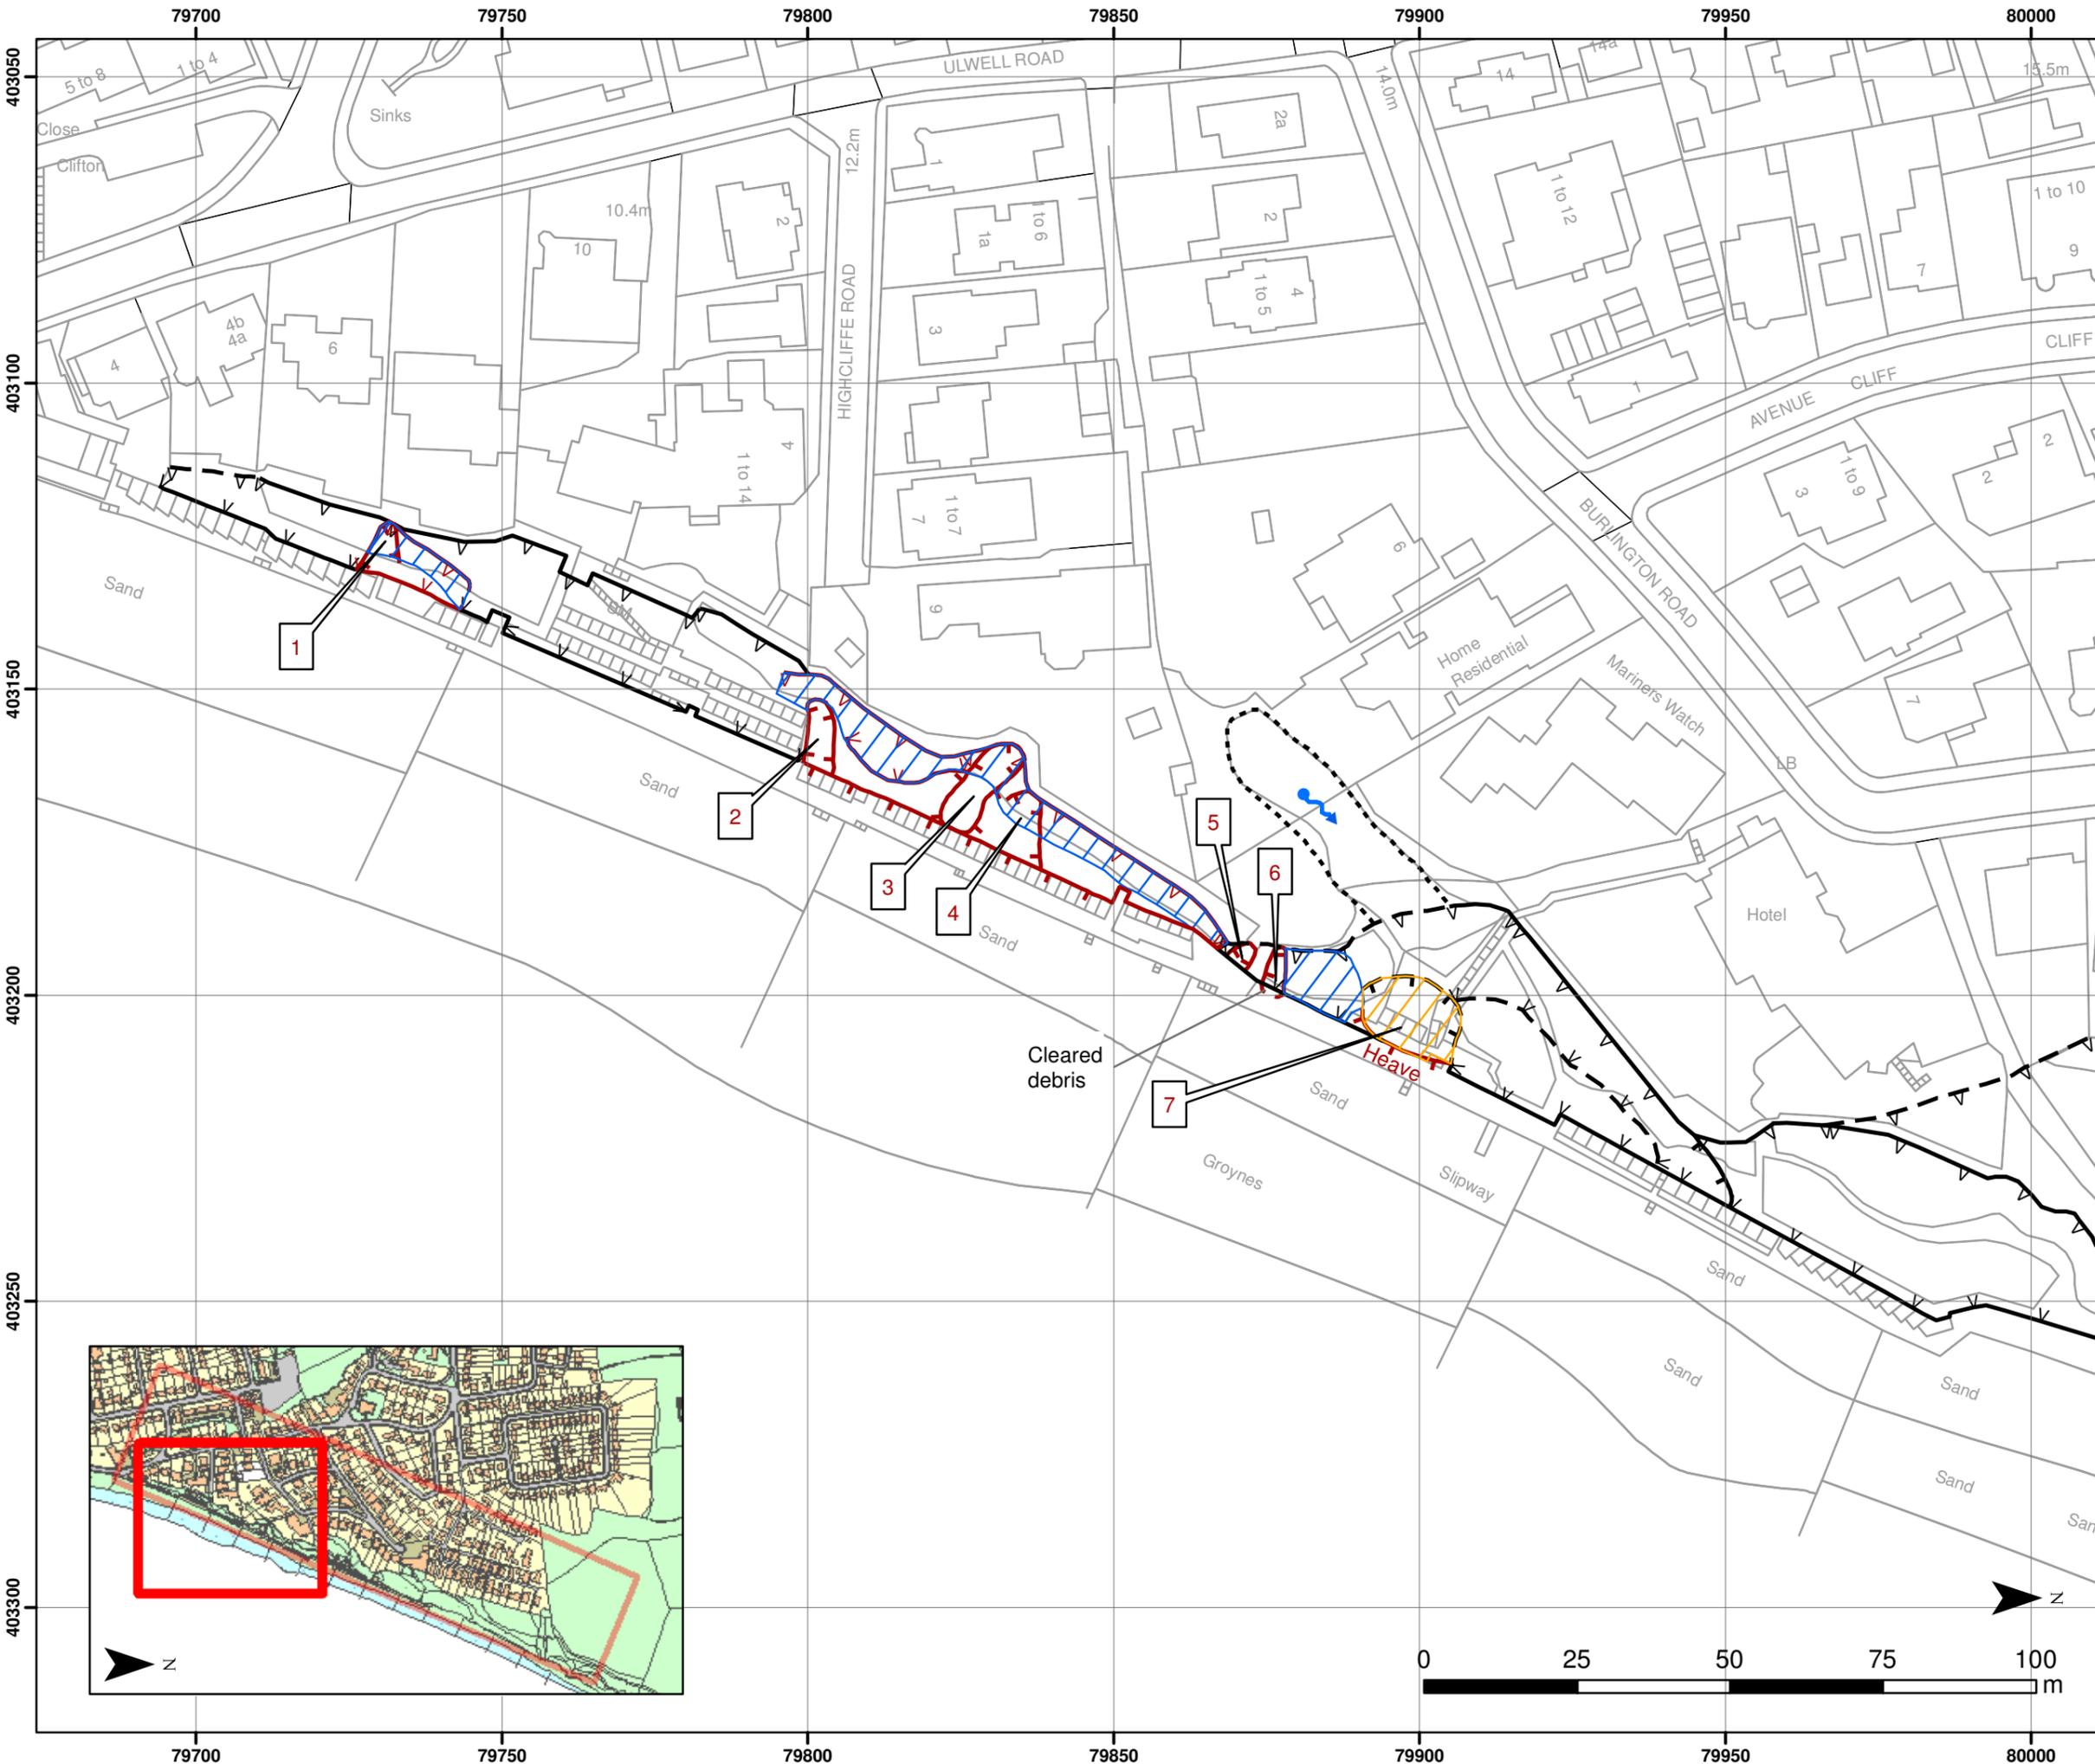
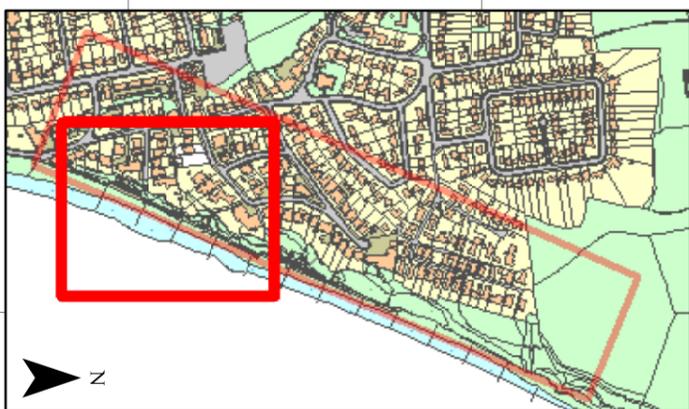
Figure 2:
Swanage North Beach
Cliffs Geomorphology
and Recommended
Works

A large cliff failure and landslip occurred at site 8 (Figure 2) which was captured on film and reported in the media 2012 (BBC online news, 22 Dec 2012). The slip measures approximately 15m by 17m with an estimated volume of 127m³. The landslip debris ran-out and came to rest upon a 3-tier and adjacent 2-tier block of beach huts and promenade (Plates 7-11). Although a significant mass of debris came to rest on the beach huts (of block-wall and concrete slab roof construction) they appear structurally intact. Some clearance of debris from the upper terrace and beach huts roof had been carried out at the time of the inspection.

The cliffs fronting properties 30-32 Burlington Road (Figure 2; Plates 12-14) had been affected by small-scale landslip for several years (Halcrow 2005). Over the period late Dec 2012 and March 2013, large-scale failure of the cliffs occurred, forming two elongate mudslides with a distinctive source, track and debris lobe. The mudslides are up to 36m long from crest to toe, 10m wide, and between 0.5-1.5m deep, with an estimated total volume of displaced material up to 400 m³.

The cliffs fronting the Pines Hotel were affected by widespread instability between Dec 2012 and Mar 2013 (Figure 2; Plates 15-17). The cliffs may be sub-divided into 3 main sections, the cliff-top, mid-cliff and lower cliff. Failure of the mid-cliff section has resulted in run-out and deposition of debris on the promenade and upper beach; this in turn has resulted in collapse and recession of the cliff-top by up to 10m measuring 60m across (Plates 16-17). Two main areas of deposition are shown in Figure 3 measuring 15m by 25m and 40m by 12m, and between 0.5m to 1.5m deep; estimated total volume of displaced debris is 855 m³. The primary cause of failure is attributed to the extreme rainfall and groundwater levels experienced over the autumn and winter period.

The adjacent property to the north of the Pines Hotel (Figure 2) has been subject to major failure in the form of an elongate mudslide with a distinctive source, track and debris lobe. The mudslide is up to 50m long from crest to toe, 23m wide, and between 0.5-1.5m deep, with an estimated total volume of displaced material up to 525 m³.

- Cliff Stabilisation
- Netting and Pinning
- Debris Removal
